PENNSYLVANIA
TROUT LAKE DAM

NDI - PA 00769
PA DER 45-43

PHASE I INSPECTION REPORT
NATIONAL DAM INSPECTION PROGRAM

Name of Dam: Trout Lake Dam
County and State: Monroe County, Pennsylvania
Inventory Number: PA 00769

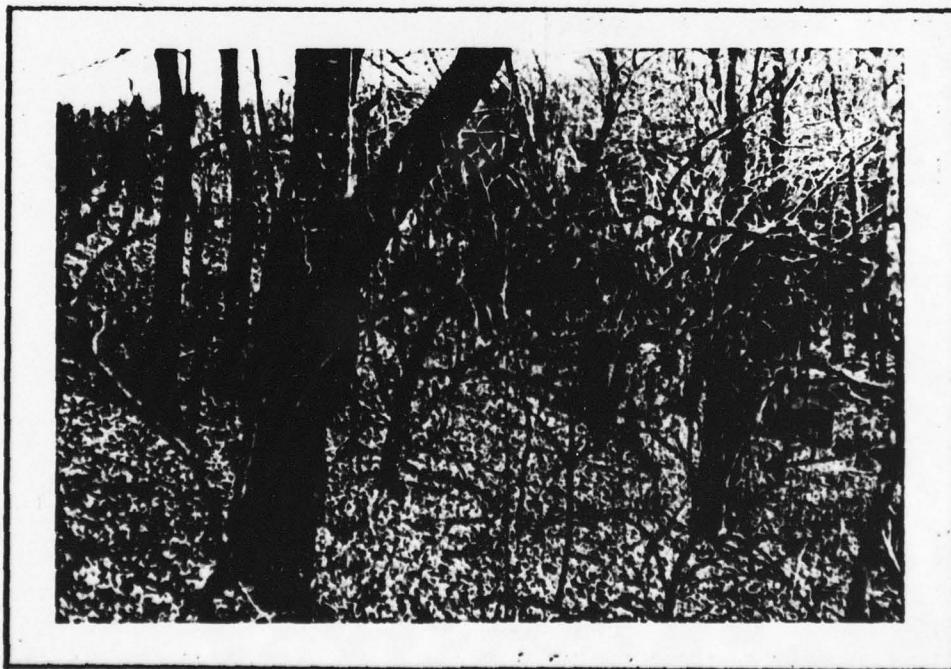
THE DOWNSTREAM SLOPE OF THE DAM

The heavy cover of large trees on the downstream slope may increase the seepage potential through the embankment. Uprooting of the trees by high winds could cause substantial volumes of embankment material to be displaced.

5. The trees and brush growing on the embankment slopes should be cut to root level and removed from the surface of the structure. A further investigation should be made to determine the extent of the root systems before remedial measures can be recommended. The downstream slope should then be seeded with suitable vegetation.

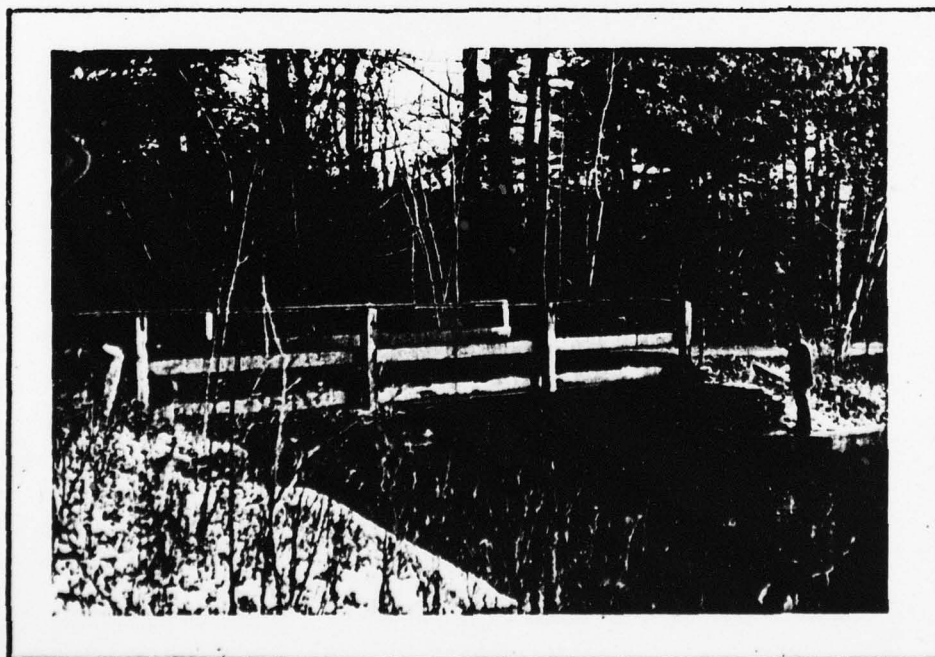
APPROACH CHANNEL TO THE SPILLWAY

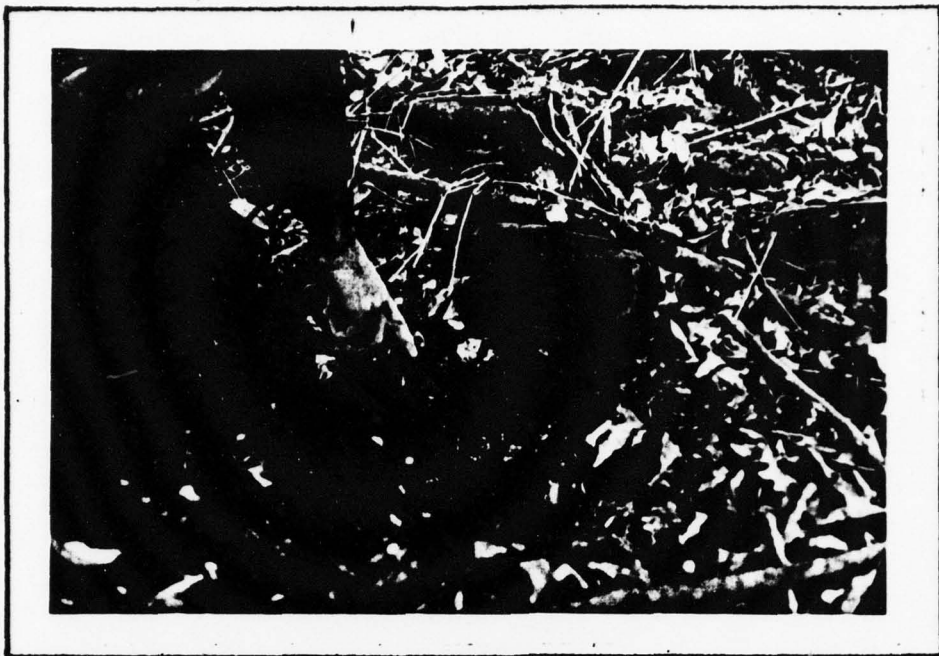
2. Immediately downstream of the embankment is an area of seepage, saturated silty deposits, and standing water. This area should be monitored regularly for signs of increased seepage and/or turbid water.

*SEEPAGE IMMEDIATELY DOWNSTREAM OF
THE RIGHT ABUTMENT OF THE DAM*

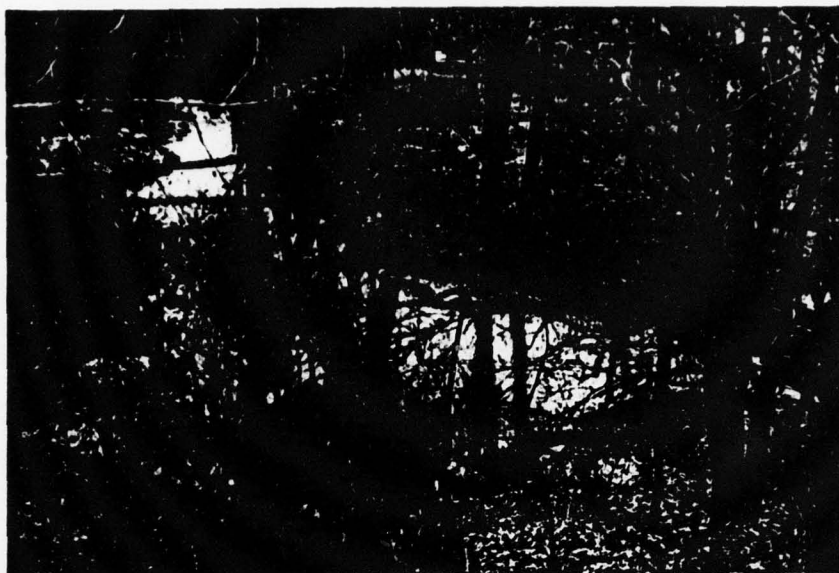
*FLOW DOWNSTREAM OF THE DAM FROM THE RESERVOIR
DRAIN SYSTEM, A TRIBUTARY IMMEDIATELY DOWNSTREAM
AND TO THE RIGHT OF THE DAM, AND FROM SEEPAGE*

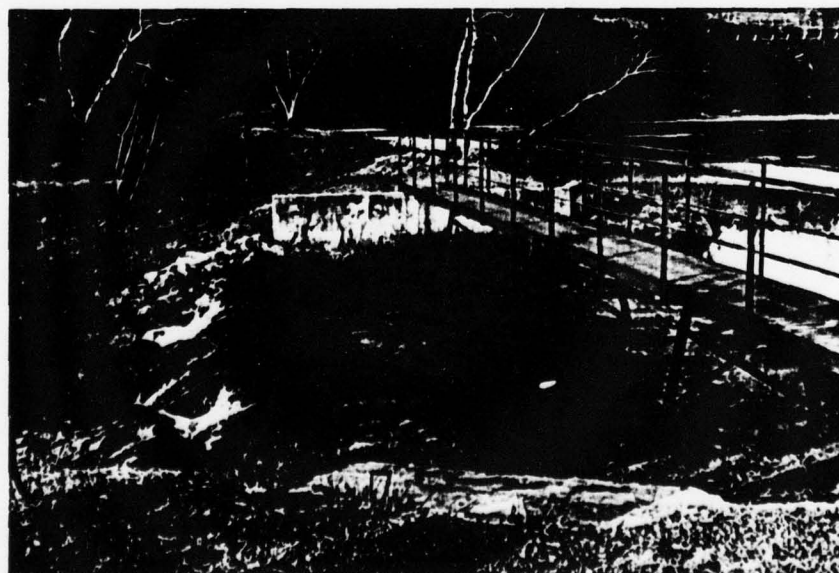
Gruber Lake, located about 400 feet downstream of Trout Lake Dam, is about $\frac{1}{2}$ mile long. Gruber Lake Dam is an earth embankment about 15 feet high and 300 feet long. The dam is provided with a 45-foot masonry, broad-crested weir constructed approximately 3 feet below the top of the embankment. The town of Appenzell is located about 3000 feet downstream of Gruber Lake. Several homes and a church are located along the banks of Appenzell Creek. Failure of Trout Lake Dam would cause significant property damage and probable loss of life.

*DAM AND SPILLWAY OF GRUBERS LAKE ABOUT
ONE HALF MILE DOWNSTREAM OF TROUT LAKE DAM*

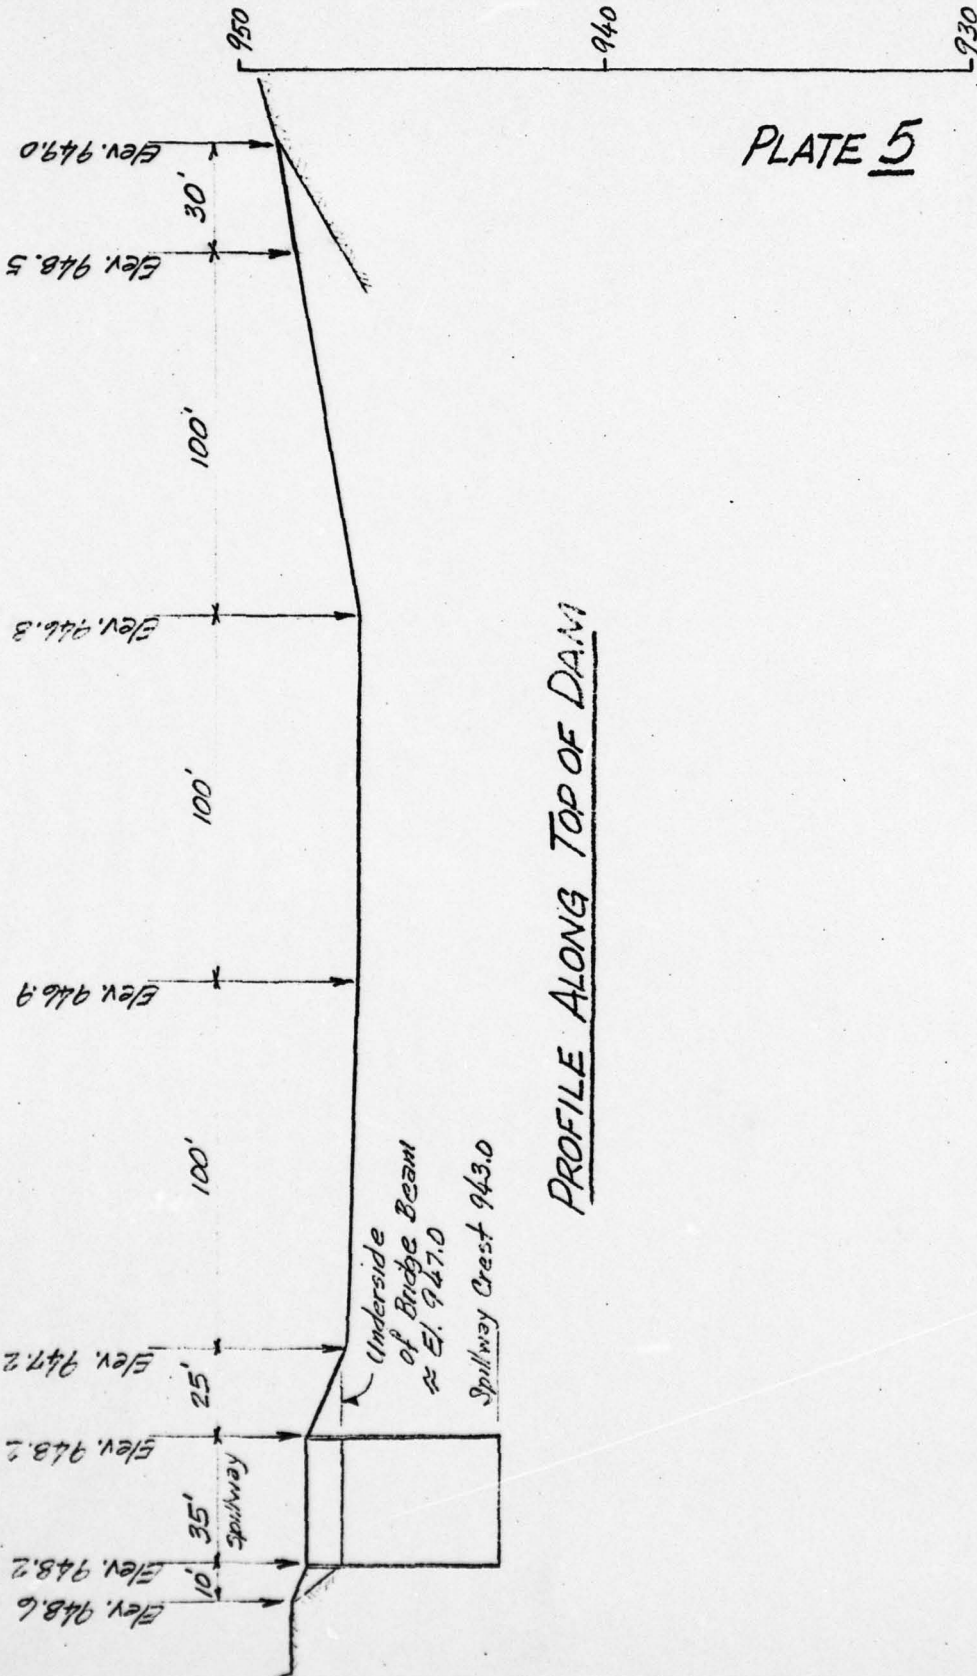
PROFILE ALONG TOP OF DAM

6. The upstream face is not provided with slope protection. Slope protection should be provided to prevent damage from wave action.
7. Portions of the top of the embankment were found to be below design elevation. Areas below design elevation should have additional fill placed and compacted to regrade the embankment to design elevation.
